# **UBC ACTS Terminal Operation and Maintenance**

**Bruce Dow,  
Scientific Engineer,  
UBC Electrical and  
Computer Engineering**

## **Terminal Operation and Maintenance Summary**

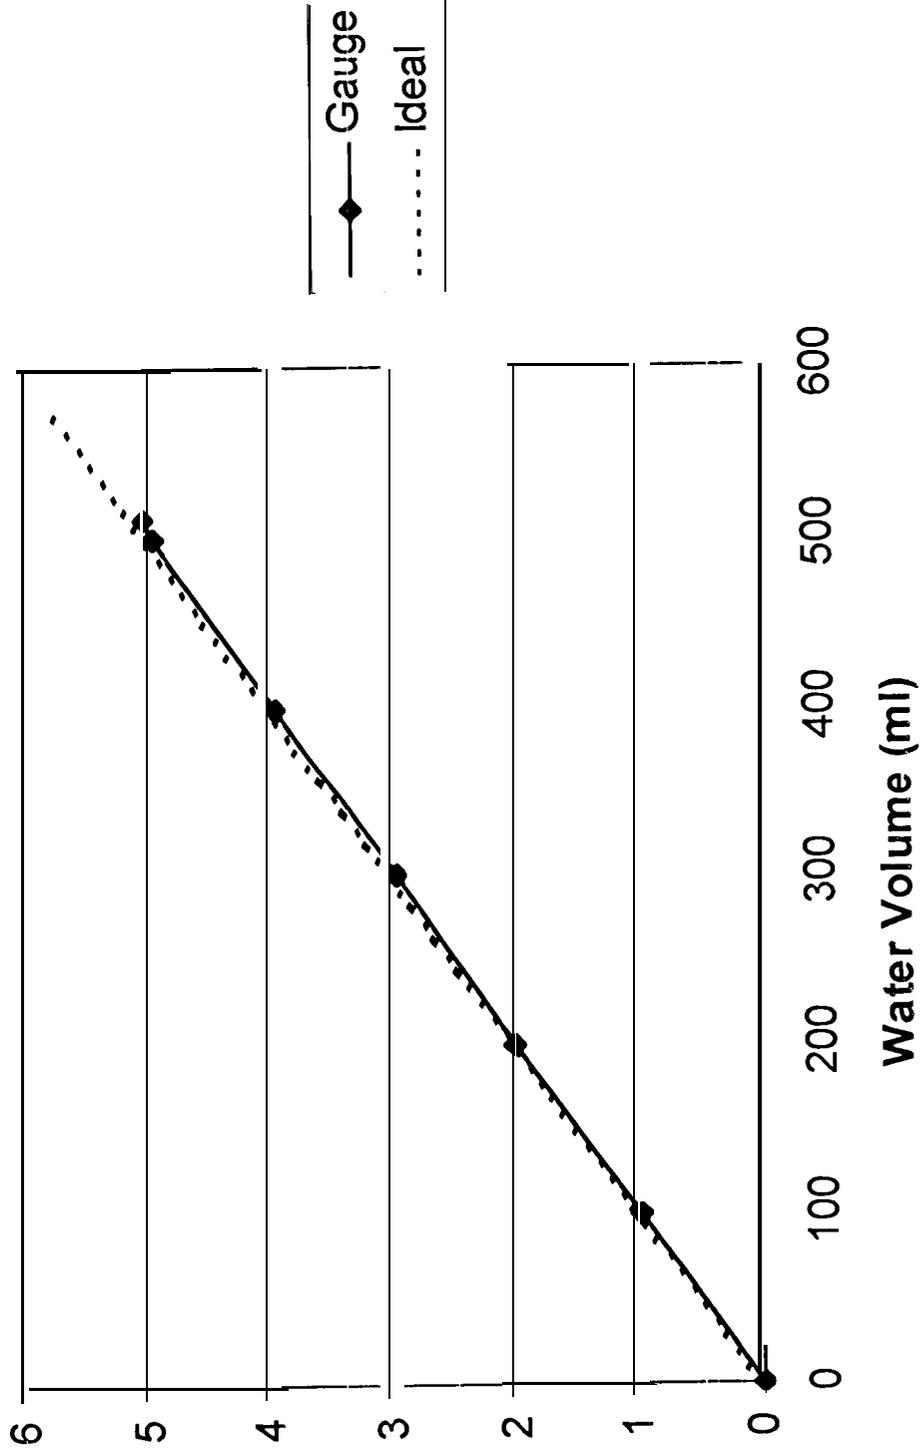
### Young Capacitive Rain Gauge Calibration at UBC Site 980721

- The Young capacitive rain gauge was received back from being repaired and calibrated, and was **re-installed** on the roof. Correct operation and calibration were verified.
- The amplifier enclosure of the CTS-10 Coordinated Time Link antenna was opened, inspected, cleaned out, and sealed with silicone seal before being put back into service. This preventative maintenance was suggested by Mr. Westenhaver.

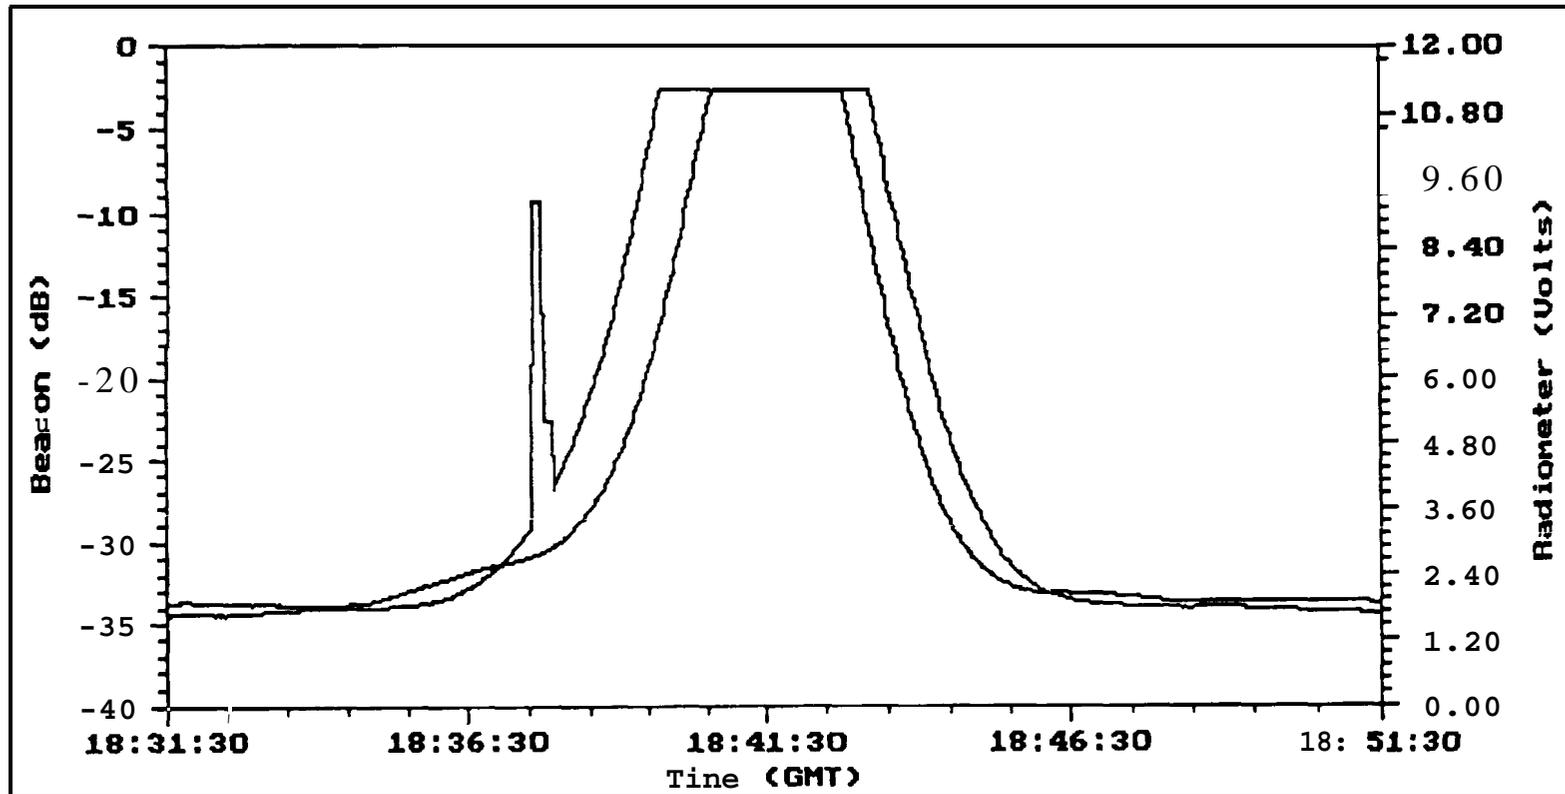
Old Antenna Pattern

Source: 980301BC.RV0

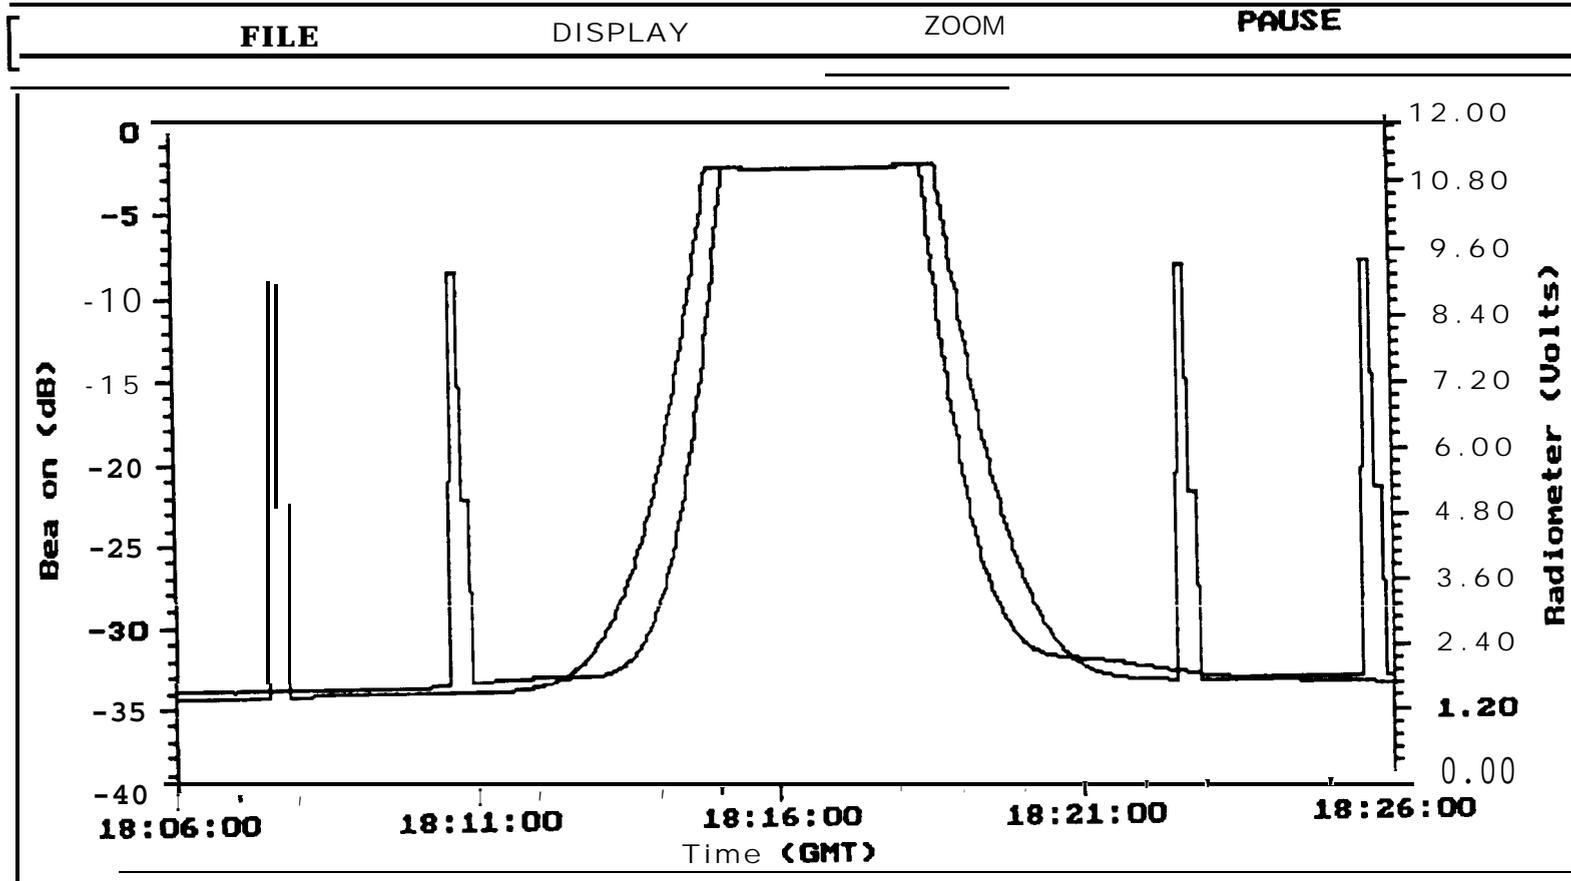
# New Antenna Pattern

Source: 981011bc.RV0
